# Manhole Inspection Summary

Manhole # S05WW1010MH

Insp Date: **9/12/06 11:16 AM**

**Location** Address: **5721 HIGHGATE DR**

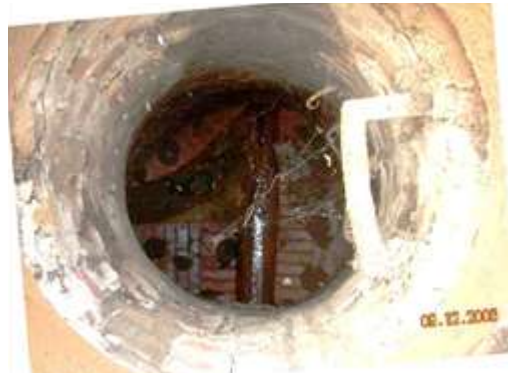
Top View

Evidence of surcharge - Bench debris.  
Channel debris.

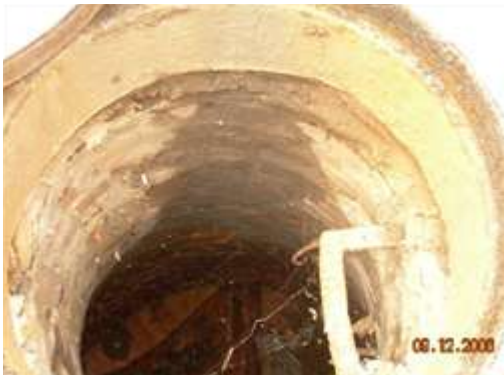
Defect

Frame leaks. Adjustment and Corbel  
deterioration and infiltration. Corroded  
and missing steps.

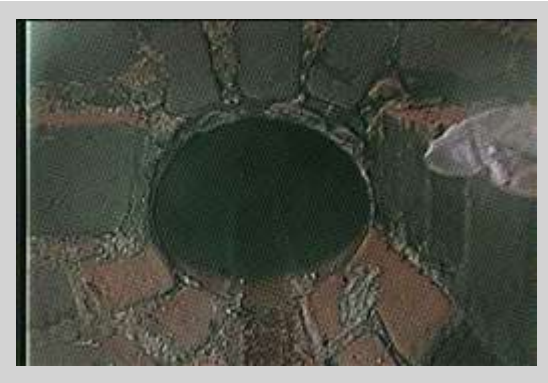
### 8 in. Circular Gravity Sewer Pipe Out @ 12 O'Clock

Barrel deterioration and infiltration.

Infiltration: **None** Pipe Seal Cond: **Cracked**

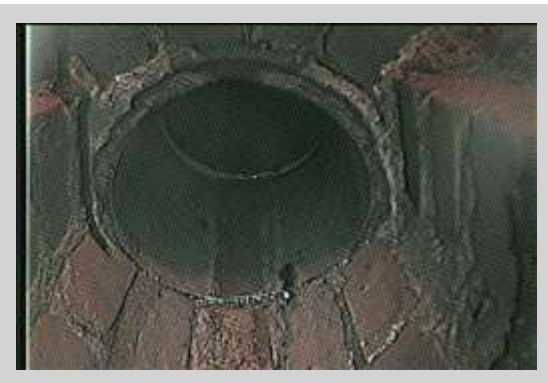
### 8 in. Circular Gravity Sewer Pipe In @ 6 O'Clock

Barrel deterioration and infiltration. Channel deterioration.

Infiltration: **Evidence** Pipe Seal Cond: **Unknown**

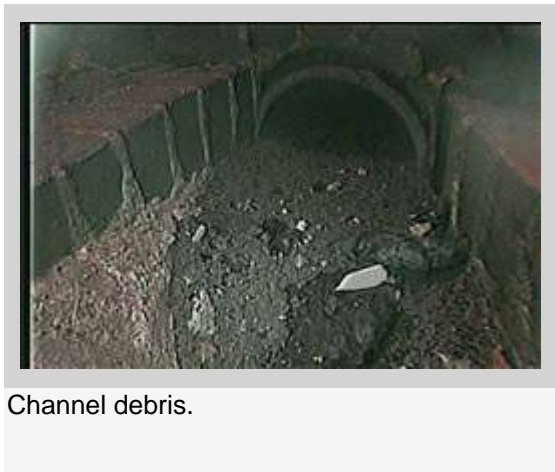
Pipe In @ 9 O'Clock

Channel debris.

Pipe Material: ☐ Pipe Lined  
Invert Depth: (ft.) Flow Characteristics: **None**  
Deposits: ☐ None ☒ **Mud** ☐ Sludge ☒ **Debris** ☐ Grease  
Silt Depth: **3** (in.) Deposits Extent: **Heavy**  
Infiltration: **None** Pipe Seal Cond: **Unknown**
